MEMORANDUM

TO: Mayor and Council
FROM: Heather Arcos, Town Manager *HJA*
DATE: September 7, 2012
SUBJECT: Update on the Acquisition of Bank of America properties

Bank of America Property
Plan of Action

Bank of America
Inspection Report
August 20, 2012
Conditions: 75 Degrees F /Raining

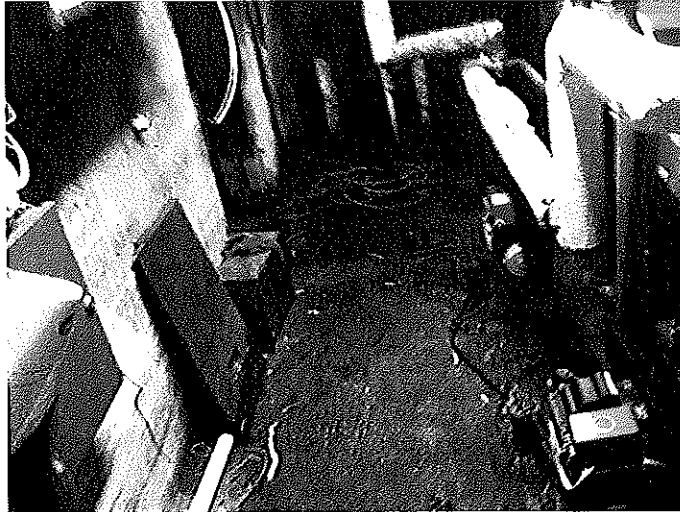
The foundation of the structure appears to be in good repair for the exception of the area in the basement which is located on the rear of the structure. During the inspection I found water flowing in through the North and East exterior basement walls. The East wall water intrusion appears to be coming from a chimney stack that is still in use as the exhaust for the two boilers that are used to heat the building. I could not determine if the water was coming from where the chimney ends on the roof (possibility of a defective collar to keep water from entering), or if there are cracks in the chimney that are allowing water in from outside grade. On the north wall water was running in the building at a pretty steady rate. This is likely just due to lack of maintenance of keeping a building below grade waterproofed. Due to the age of the building this is not an uncommon occurrence for any building with a basement in the Town. However this is of major importance to get this fixed because the basement is part of the foundation and plays a major role of the structural stability of the building. Also the heating system for the entire building is in the basement and the systems will not last with the major flooding that is possible.

Figure 1- Basement Very Damp

Major: Fix water intrusion issues **\$10,000**

Secondary Major: Flood Proof Basement Walls **\$40,000** (Important fix to protect mechanical systems and structural stability of the building but not needed to be done immediately)

Minor: Add De-Humidifier **\$1,000**

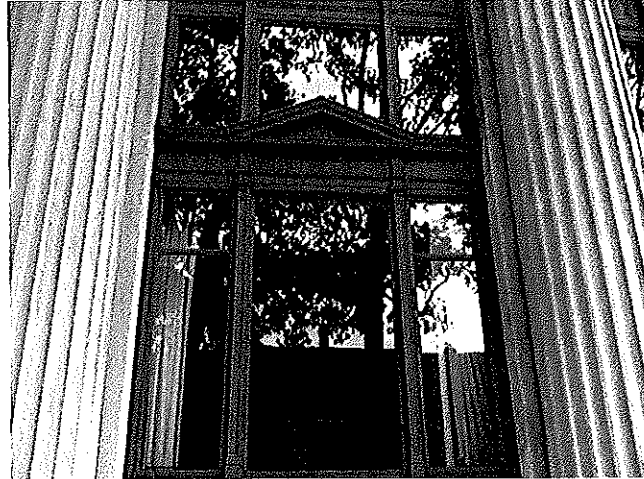
Figure 2 - Window Cracked at Top

Minor: Replace Window Pane \$500

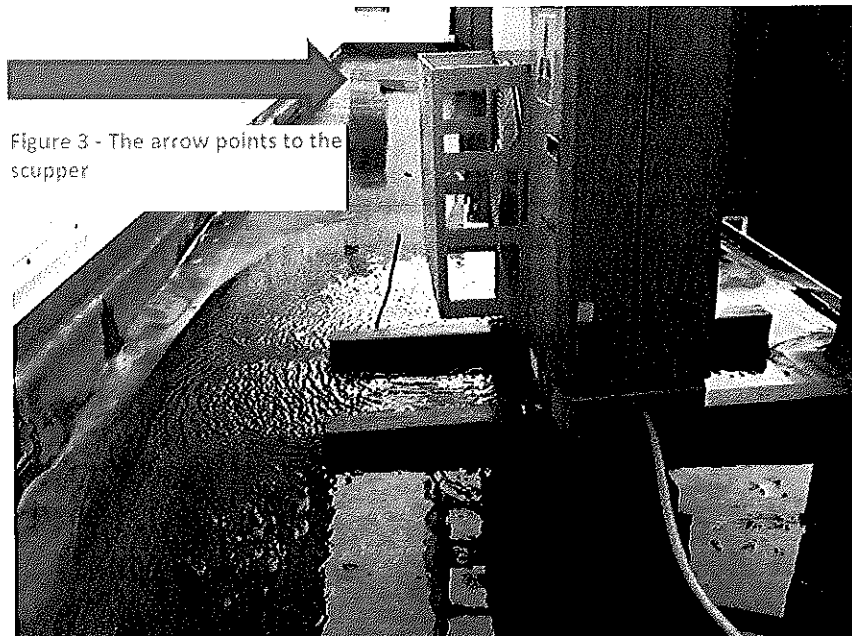
On July 18, 2012 I performed an inspection of the roof of the structure and provided a memo to the Town Manager regarding the condition of the roof. In my report I stated that based on the visual inspection of the roof that it had been maintained properly over the years with repairs being done in a timely fashion. I also stated that there was a secondary roof on the East Side of the Building that was lower than the main roof. This roof poses a problem.

Figure 3 - The arrow points to the scupper

Major: Fix standing water issue on 1st floor Roof **\$5,000**

Minor: Have roofing company come over and provide maintenance plan **\$TBD**

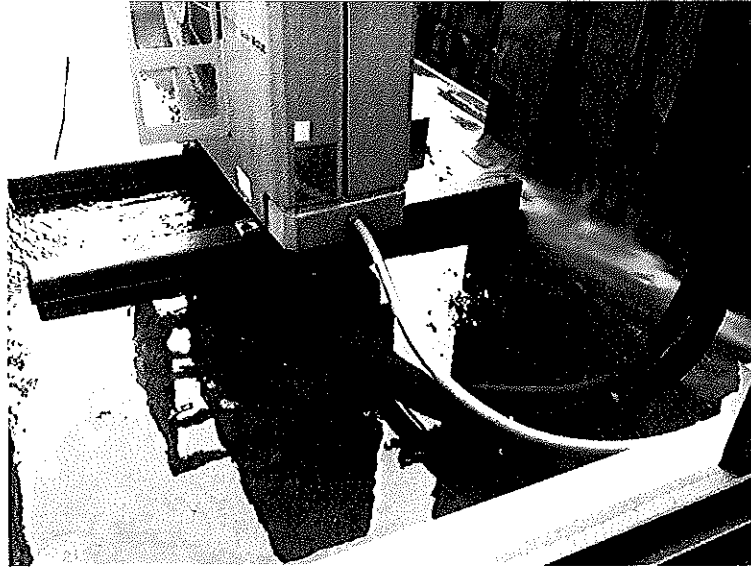
Figure 4

Recently Bank of America installed a mini-split mechanical system up on this roof to keep the space conditioned where the ATM was installed. Water is standing in the corner where this unit was installed. I was unable to determine if the weight of the unit is what has caused the pooling of the water or if this was a problem before. The concern here is that the longevity of the roofing system is greatly reduced due to the standing water sitting on the roof. There is a scupper on the other end that drains the water off the roof. (See Figure 3) This issue needs to be addressed ASAP to keep water from deteriorating the roofing membrane and causing problems in the first floor of the building.

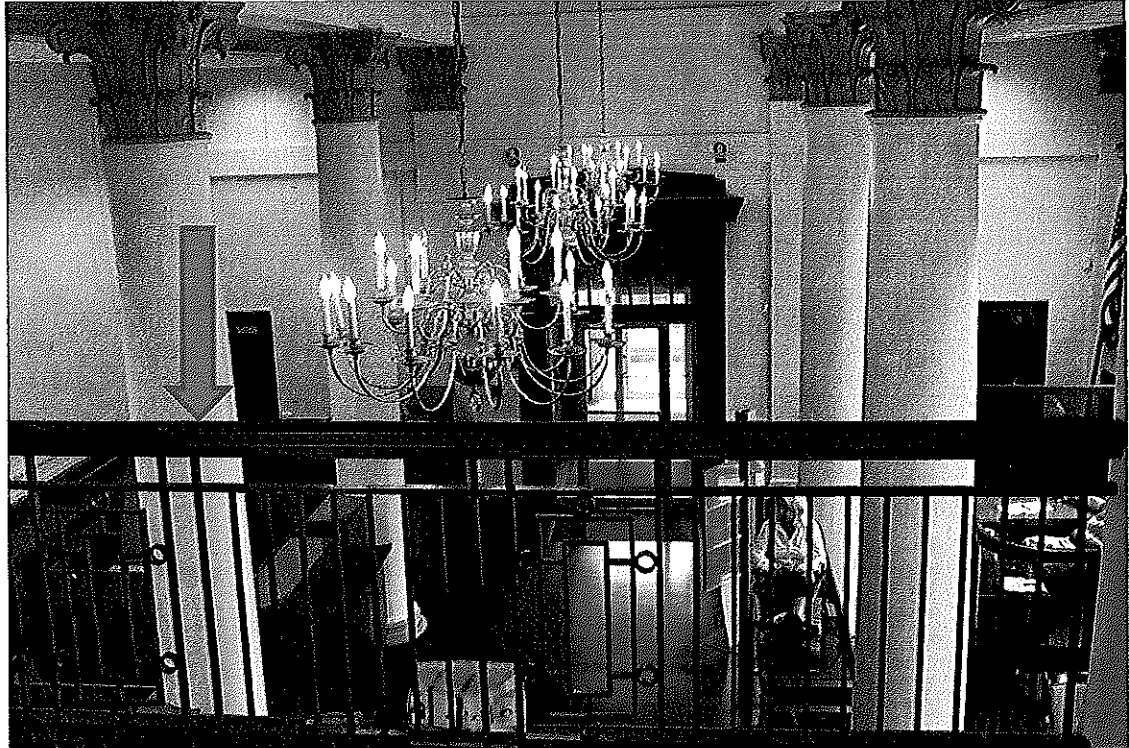
- The balcony railing on the 2nd floor loft area poses a great safety risk for anyone using the area because of the height of the railings. Current building code requirements require all railings in a commercial setting be a minimum of 42" tall off the floor. These rails are roughly 32" off the floor. There are a couple suggestions I have to resolve this. The whole balcony railing could be lined with tables for study use or computers and this would not allow access to the

Figure 4- Railing only 32" tall

railing edge. The other suggestion would be to remove the top rail and add on to the pickets to proper height and re-install the top rail.

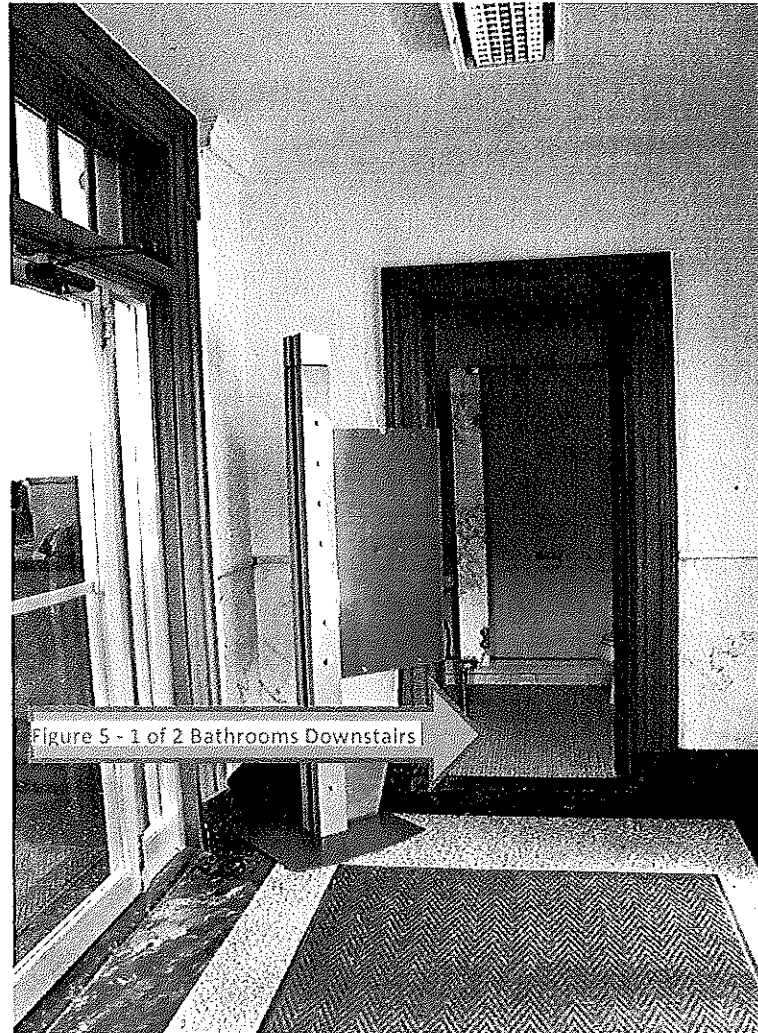
The Plumbing systems appear to be in operation and in a working condition. At the present time there are two small bathrooms on the first floor that were used by the tellers and other bank employees. Upstairs was a break room that has one sink in operable condition. I had B&B Plumbing and Heating perform a walkthrough and look at the condition of the plumbing systems. Mr. Brady stated that everything appeared to be in operating condition. Most of plumbing is under the slab therefore any moving of bathrooms would be a major cost due to having to remove some of the concrete floor. Either one of the existing bathrooms would have adequate space in it to be able to retrofit with a handicapped toilet and sink. Currently each one of the sinks is supplied by hot water heaters installed in the bathrooms. This would have to be removed to comply with the ADA regulations. The suggestions would be to install an on demand hot water heater that takes up very little room.

Figure 5 - 1 of 2 Bathrooms Downstairs
